T. TYPHOON ELLEN (050600Z-131800Z DECEMBER 1961)

TYPHOON ELLEN 05-13 DEC 1961
POSITION AND FORECAST VERIFICATION DATA

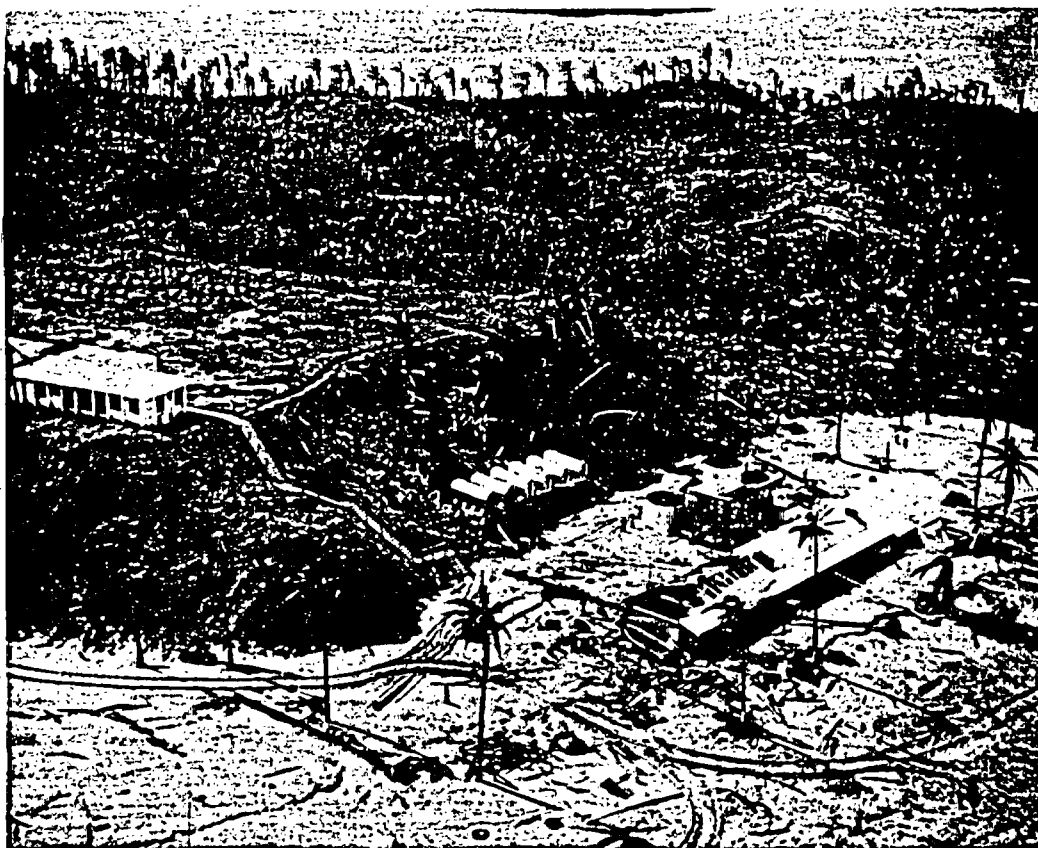
DAMAGE WAS EXTENSIVE, INCLUDING THE ELECTRICAL, WATER AND SEWAGE SYSTEMS, AND NEARLY ALL BUILDINGS AND VEHICLES. THE DAMAGE WAS DUE TO HIGH WINDS, FLYING OBJECTS, FLOODING AND RAIN. IN MANY CASES SEVERAL FEET OF SAND REMAINED BEHIND TO BE REMOVED LATER.

AERIAL PHOTO SHOWING PART OF DAMAGE CAUSED BY ELLEN TO CGLORSTA, CATANDUANES ISLAND, 9 DECEMBER 1961. (OFFICIAL NAVY PHOTO)

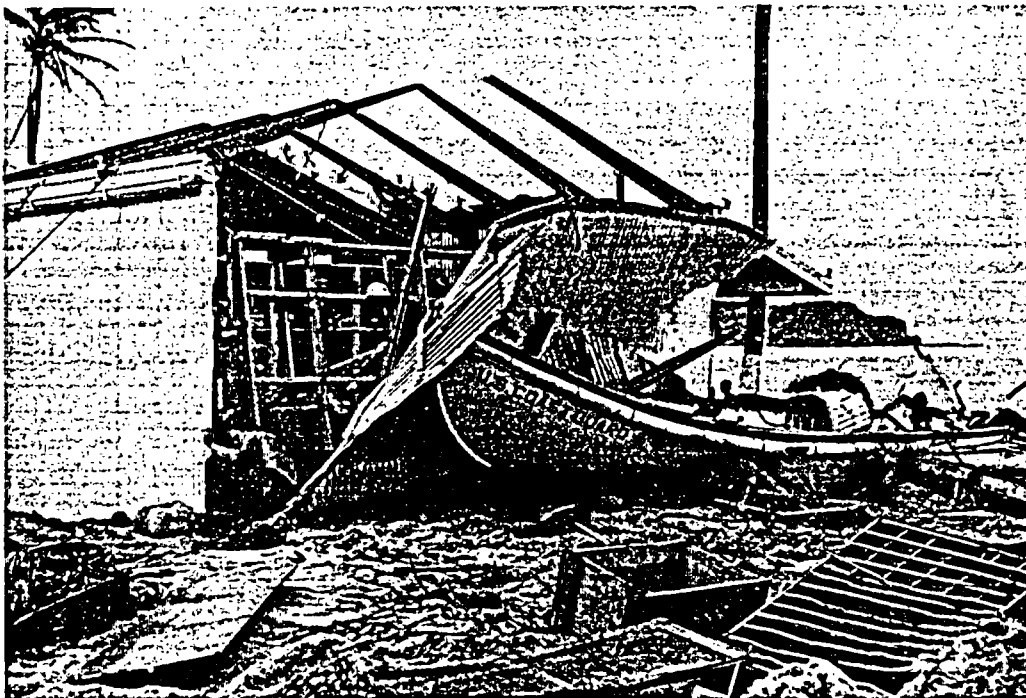
DAMAGE TO BUILDING AND BOAT CAUSED BY ELLEN, 9 DECEMBER 1961. (OFFICIAL NAVY PHOTO)
